DAMAGE ANALYSIS

LUBRICATION-RELATED

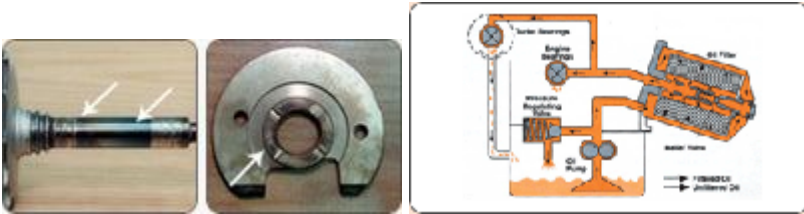
1. Dirt In Oil

Foreign materials in oil, metal shavings, abrasives from inadequate filtration and dilution can score the bearings and destroy the oil film that supports the shaft. Dirty oil damages the turbocharger with heavy scoring of critical bearing surfaces.

Causes:

- Blocked, damaged or poor quality oil filter.
- Dirt introduced during servicing.
- Engine wear or manufacturing debris.
- Malfunctioning of oil filter bypass valve.
- Poor quality oil carbonising.
